## Measuring deformation related to active sinkholes with ground-based 3D laser scanner. A case study in the evaporite karst of the Ebro Valley, NE Spain

A. Benito-Calvo<sup>1</sup>, F. Gutiérrez<sup>2</sup>, D. Carbonel<sup>2</sup>, G. Desir<sup>2</sup>, J. Guerrero<sup>2</sup>,  
O. Magri, T. Karampaglidis<sup>1</sup> and I. Fabregat<sup>2</sup>

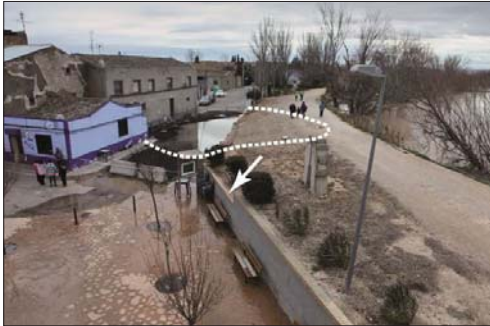
FIGURE 2. Image showing the location of the Alcalá sinkhole. The dashed line indicates the approximate limits of the area affected by higher subsidence. Arrow in the lower part of the image points to the northernmost fissure in the concrete wall. The photograph was taken on March 2, 2015, during the February-March Ebro River flood with a return period of 5-10 years. The water stage in the river is well above the ground surface in the village and water from the river was flowing under pressure through and beneath the dike, flooding the sinkhole

The Alcalá sinkhole, selected to illustrate the approach in this paper, is located next to the Ebro River channel and affects a flood-control dike, the adjacent street and two buildings

(Fig. 2). This sinkhole with recurrent collapse activity significantly contributes to reduce the mechanical strength of the dike, leading to high-risk situations during flood events.

At Alcalá, during several days, the water stage in the river was well above the ground surface in the village, and river water was flowing under pressure through and beneath the dike, causing internal erosion and flooding the sinkhole with turbid water (Fig. 2). In December 2015, a new consolidation grouting program was carried out along the dike though 84 borings with different depths (17 at 15 m, 22 at 9 m, and 45 at 5 m). Grouting was performed by injecting under pressure a hydro-active polyurethane foam generated by the mixture of two components (MasterRoc® MP355 by BASF). This solvent-free resin has been designed for rapid water stopping, ground consolidation and small-cavity filling within the phreatic zone. In contact with water it rapidly reacts to form a rigid foam. The foaming factor and the me-

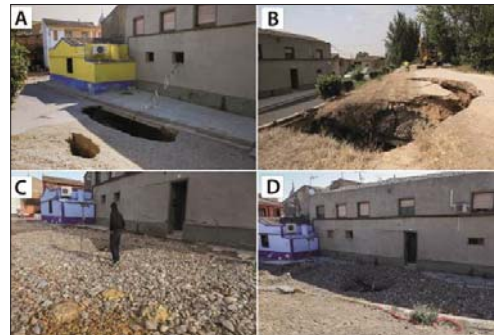
FIGURE 5. Photographs illustrating the evolution of the Alcalá sinkhole since 2007. A: Collapse sinkhole that reappeared in July 6, 2007, after filling a depression formed on June 20, 2007. Image taken on July 8, 2007. Note the lack of cracking in the adjacent buildings. B: Collapse sinkhole occurred in November 2013 on the eastern flank of the dike. C: Collapse-suffosion sinkhole formed soon after the compaction grouting program applied in the street with expansive polyurethane foam during November-December 2013. Note severe cracking in the adjacent buildings. Image taken on December 31, 2013. D: Collapse sinkhole on May 9, 2014

On June 20, 2007, a collapse sinkhole occurred suddenly in the street next to the sidewalk of the buildings (Fig. 4). This was a bell-shaped shaft with overhanging edges approximately 8 m across and 15 m deep. It partially undermined the adjacent house, which was evacuated. The hole was filled with 500 tonnes of gravels and boulders, plus sluggish cement, indicating a minimum volume for the subsurface cavity of around 750 m<sup>3</sup>, considering a bulk density for the non-compacted aggregate of 1.5 g/cm<sup>3</sup>. Probably, the development of the sinkhole was favoured by water level changes in the alluvial aquifer related to a flood in the Ebro River during March and April 2007 (peak discharge of 2230 m<sup>3</sup>/s in Zaragoza city on April 5, 2007) and the subsequent flow recession. The house was reoccupied on July 6, 2007, and a few hours later a collapse sinkhole around 2 m across formed next and beneath to the sidewalk (Fig. 5A). In November 2013, a new collapse sinkhole around 9 m long and with overhanging edges formed on the eastern flank of the dike (Figs. 4 and 5B).

ings, in order to increase the bearing capacity of the ground and fill the cavities. An expansive polyurethane resin was injected under pressure through small-diameter borings from 5 to 8 m depth. Soon after the injection, a collapse sinkhole formed in front of the building (Figs. 4 and 5C, D).
